**DEPARTMENT OF TRANSPORTATION**

Contract #: 04-0120F4Cty: SF/ALA Rte: 80 PM: 13.2/13.9File #: 69.28**WELDING INSPECTION REPORT****Resident Engineer:**Pursell, Gary**Address:** 333 Burma Road**City:** Oakland, CA 94607**Report No:** WIR-014110**Date Inspected:** 25-Jan-2010**Project Name:** SAS Superstructure**OSM Arrival Time:** 700**Prime Contractor:** American Bridge/Fluor Enterprises, a JV**OSM Departure Time:** 1900**Contractor:** Zhenhua Port Machinery Company, Ltd (ZPMC), Changxing Island **Location:** Shanghai, China

**Bridge No:** 34-0006**Component:** Tower**Summary of Items Observed:**

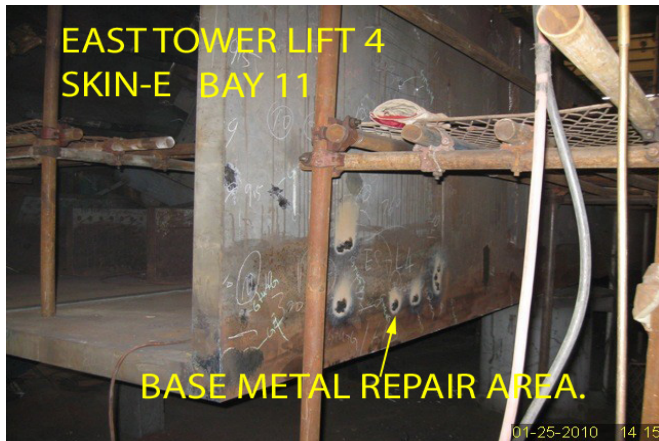
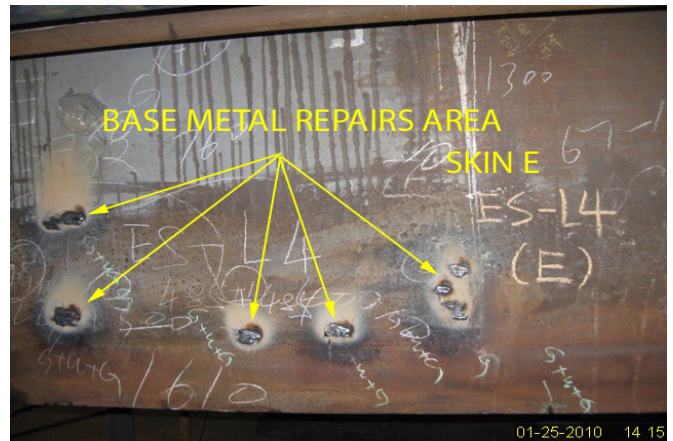
During in process visual inspection (in Bay 11); the below mentioned activity was noted, which did not appear to comply with the applicable contract document.

Base Metal Repairs were performed without prior approval from the Engineer. Base Metal Repairs were performed using the Shielded Metal Arc Welding (SMAW) process where East Tower Lift 4 Skin E, on the 485 grade material. The following Skin Plate were repaired: EAST TOWER LIFT 4 SKIN E,

For further information, please see the attached photos.

This QA informed ZPMC Quality Control (QC) identified as Mr. An Qing Xiang and American Bridge Fluor (ABF) QA identified as Mr. Man Kam Hen of this issue and that an incident report would be generated.
